**FIRE RESISTANCE TEST IN ACCORDANCE
WITH AS1530.4-1997 SECTIONS 2 & 3 AS
APPROPRIATE ON A NON-LOADBEARING
STEEL STUD PARTITION INCORPORATING
A PHENOLIC FOAM INFILL AND FACED WITH
INSUL-CRETE SUNBLOK**

Insul-crete Pty Ltd
628 Skipton Street
Ballarat
Victoria 3350
AUSTRALIA

Report Sponsor	Insul-crete, 628 Skipton Street, Ballarat, Victoria 3350, Australia.
Test Laboratory	Warrington Fire Research (Aust) Pty Ltd, Unit 2, 409-411 Hammond Road, Dandenong South, Victoria 3175, Australia.
Test Date	5th June 2001.
Test standards	AS1530.4-1997 Sections 2 & 3 as appropriate.
General description of tested specimen	<p>The test assembly comprised a nominal 3000mm × 3000mm × 145mm thick steel stud partition incorporating a phenolic foam infill and faced with a render material named by the test sponsor as insul-crete sunblok. The partition was constructed by the test sponsor within a concrete block lined steel test frame supplied by Warrington Fire Research (Aust) Pty Ltd. The steel stud partition was constructed using BHP House framing studs and tracks (Nominal 75mm x 35mm x 0.75mm). The top and bottom tracks were fastened to the concrete block surround and the studs were fastened to the top

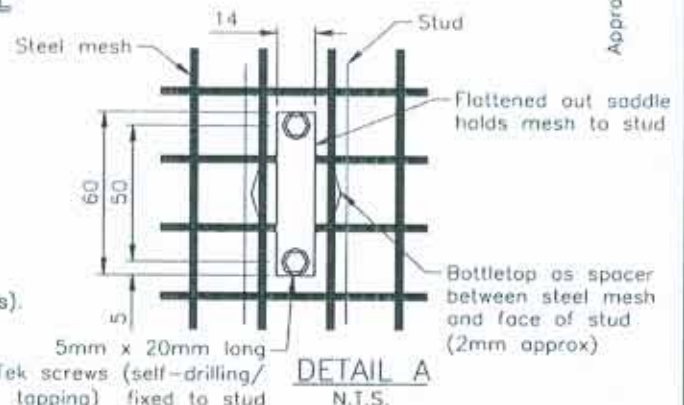
SIGNATURES		Scale	Project	Title
	SIGNED	As Shown	F91864	Insul-crete Wall Test Construction Details Pre-Render Stage
DRAWN	A F Rayner	DRG No.	F91864-TS-01	
		CAD Ref.	F91864-WALLTEST-00

- Top and bottom channel sections (stud material) (material) fastened to concrete block surround with M8 x 50 long masonry anchors at 600 centres.
- Stud along eastern side fastened to concrete block surround with M10 x 50 long masonry anchors.
- Studs fixed to top channel only with M6x25 bolts and nuts with mudguard washers (Slotted holes in studs).
- Mesh joined with five (5-off) wire twitches and three (3-off) cleats at 90° as per Detail A. Note that joints are staggered for exposed/unexposed faces.

- A1.1.7 A single layer of 25mm × 25mm × 2.5mm galvanized weld mesh made up in two sections, 2400mm wide and 600mm wide respectively, and butt jointed together with five (5-off) wire twitches and three (3-off) flattened saddles (detailed below), was fixed to both faces of the specimen. The vertical butt joints were staggered to each other with the joint on the exposed face being in the eastern half of the specimen. The fixing was achieved using flattened saddles (60mm long × 14mm wide) and self drilling and tapping hex head TEK screws (2-off per saddle) at each bottle top location (Refer Drawing F91864-

Drawing No.	Description
F91864-TS-01	Construction details
F91864-TS-02	Thermocouple positions and Deflection measurement positions
F91864-TS-03	Building Panel – Cross section of panel

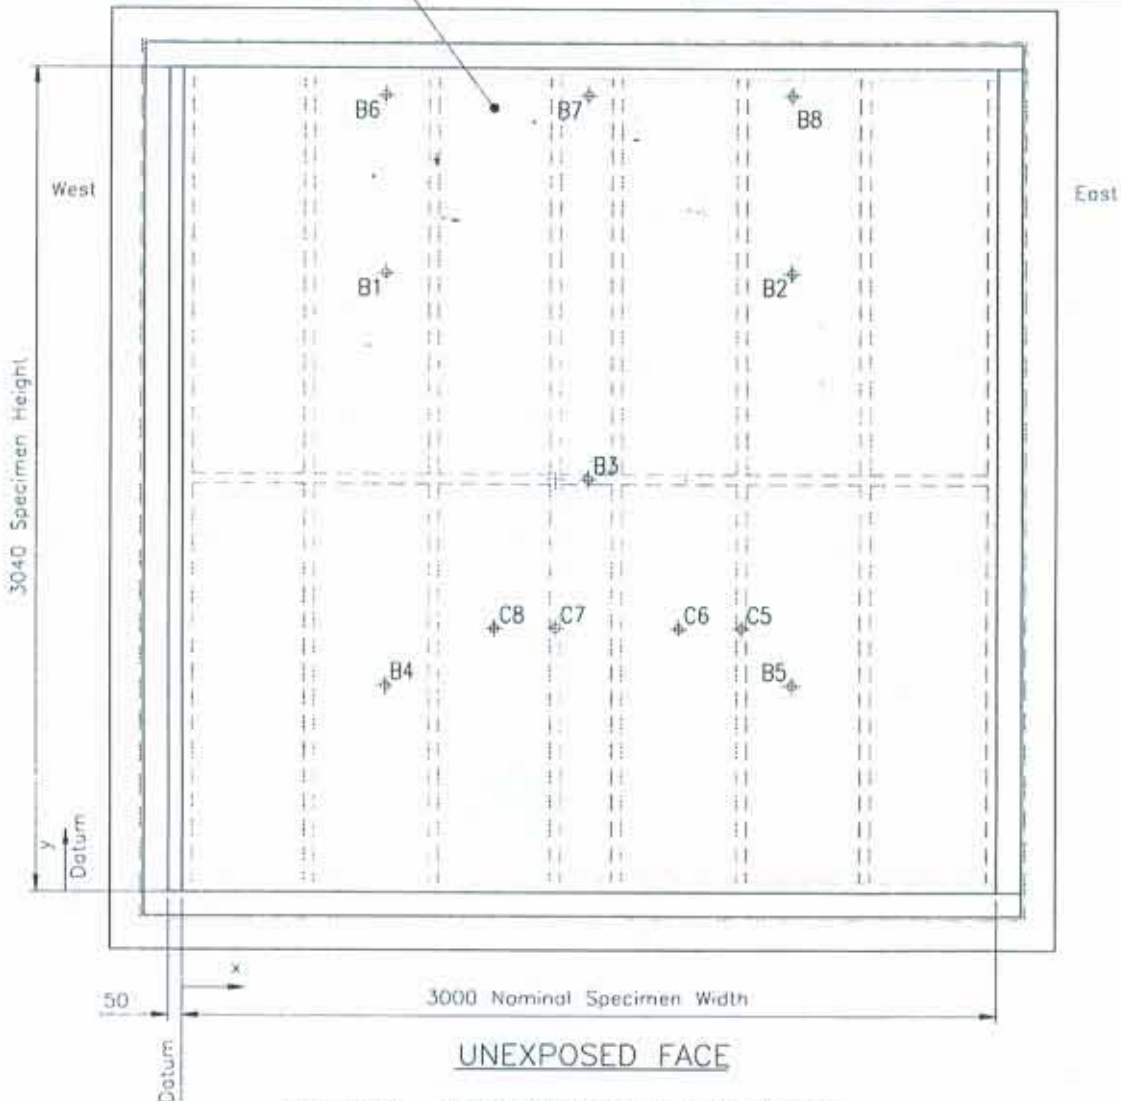
DRG No.
F91864-TS-02

SURFACE THERMOCOUPLE POSITIONS

T/C	x	y	Description	T/C	x	y	Description
B1	750	2280	Partition 1/4 point	B7	1500	2940	100mm from top edge
B2	2250	2280	Partition 1/4 point	B8	2250	2940	100mm from top edge
B3	1500	1520	Partition mid point	C5	2064	970	Lower section on stud
B4	750	760	Partition 1/4 point	C6	1834	970	Lower section between studs
B5	2250	760	Partition 1/4 point	C7	1378	970	Lower section on stud
B6	750	2940	100mm from top edge	C8	1154	970	Lower section between studs

INSUL-CRETE SUNBLOK COAT THICKNESS (AVERAGE)

Side of specimen	Coat thickness (mm)			Notes
	1	2	3	
Non-fire side	16.4	15.2	-	
Fire exposed side	15.5	18.5	3.0	3rd coat on Eastern half of specimen included an adhesive additive.

Instrumentation	<p>The instrumentation was provided in accordance with AS1530.4-1997 Sections 2 & 3 as appropriate. The positions of the thermocouples are described in Table A2.1, and are shown in Drawing F91864-TS-02. Deflection measurement positions are shown in Drawing F91864-TS-03.</p>
Test Procedures	<p>The test procedures were as specified in AS1530.4-1997 Sections 2 & 3 as appropriate. Control of the furnace temperature was maintained within the prescribed limits of variance from the time/temperature curve. The pressure was maintained at approximately 0 Pa at 500mm from the notional floor level after the first five minutes then for the duration of the test. Heating was terminated after 241 minutes at the request of the test sponsor.</p>
Test Duration	241 minutes.

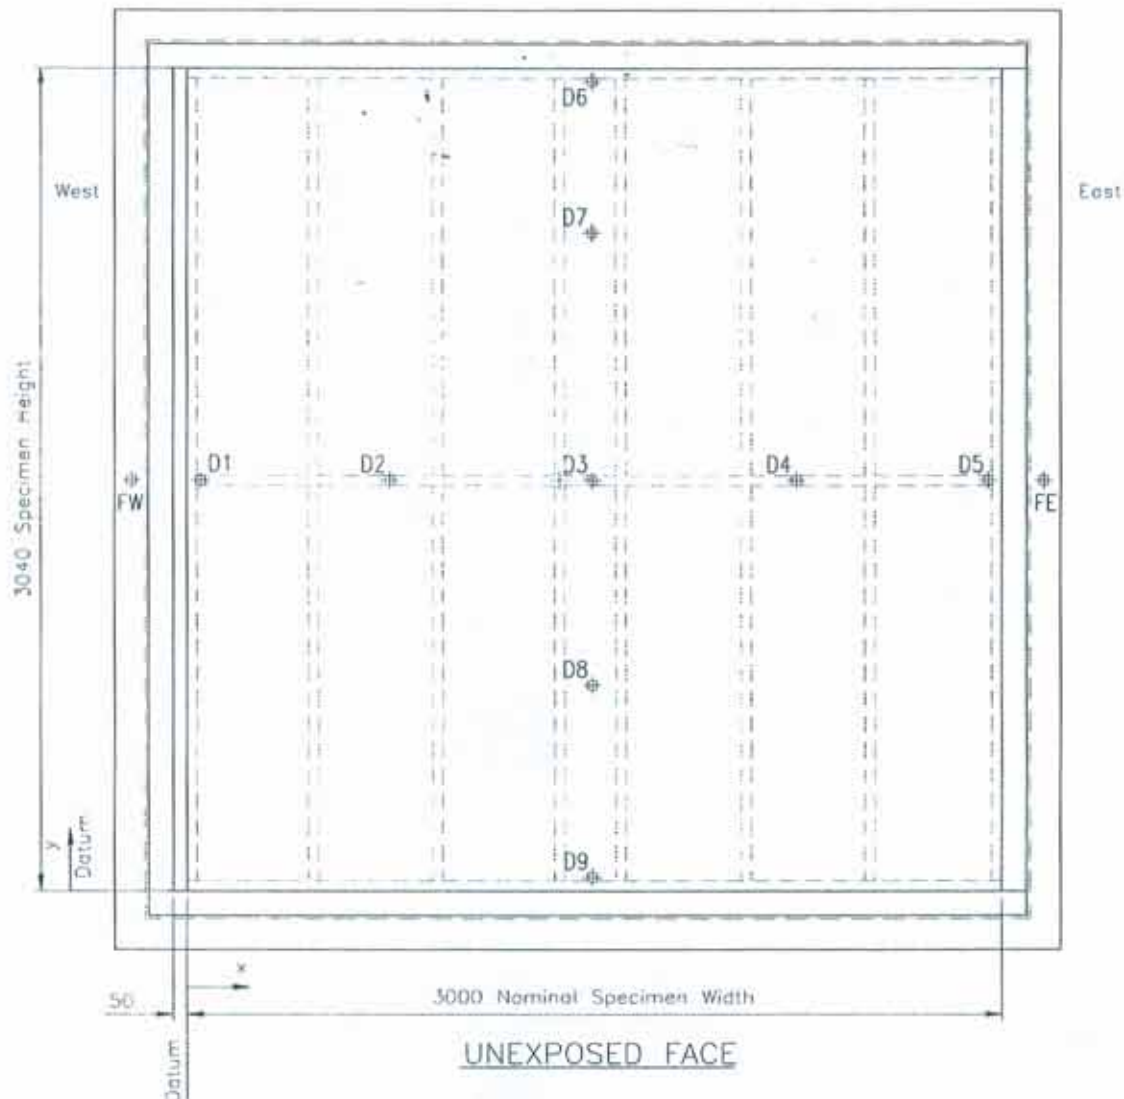
Scale	Project
1:25	F91864
DRG. No.	F91864-TS-03
CAD Ref.	F91864-WALLTEST-00

DEFLECTION MEASUREMENT POINTS

Pt	x	y	Description	Pt	x	y	Description
D1	1130	2380	Western edge (horizontal centreline)	D7	1730	1220	Upper 1/4 point (vertical centreline)
D2	1210	2380	Western 1/4 point (horizontal centreline)	D8	2260	1220	Lower 1/4 point (vertical centreline)
D3	80	1220	Midpoint	D9	1130	60	Bottom (vertical centreline)
D4	610	1220	Eastern 1/4 point (horizontal centreline)	FW	-	-	Test frame West
D5	1120	1220	Eastern edge (horizontal centreline)	FE	-	-	Test frame East
D6	1220	1220	Top (vertical centreline)

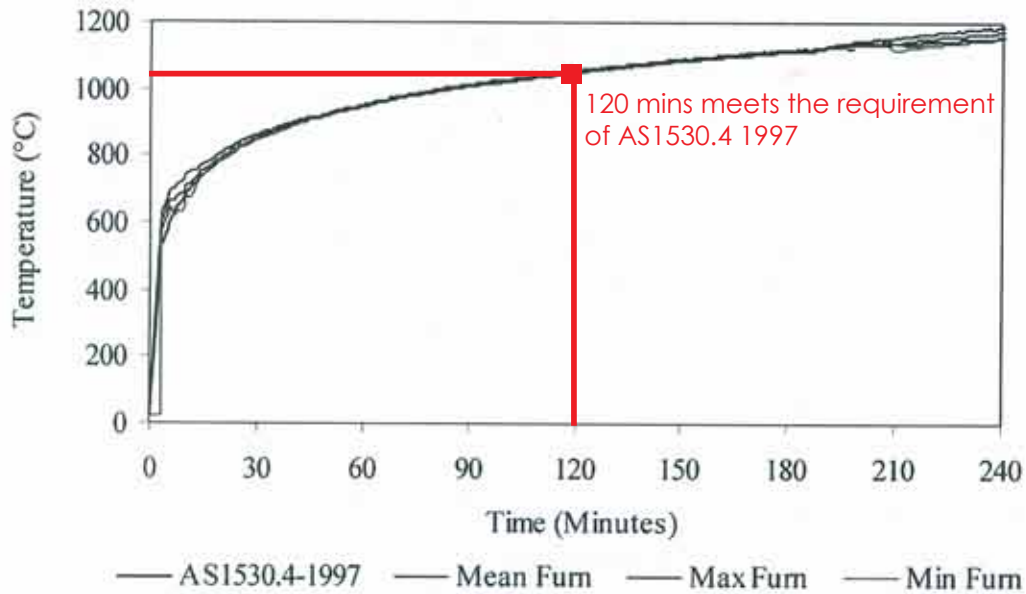
Figure A2.1: **Furnace Temperatures** versus Time

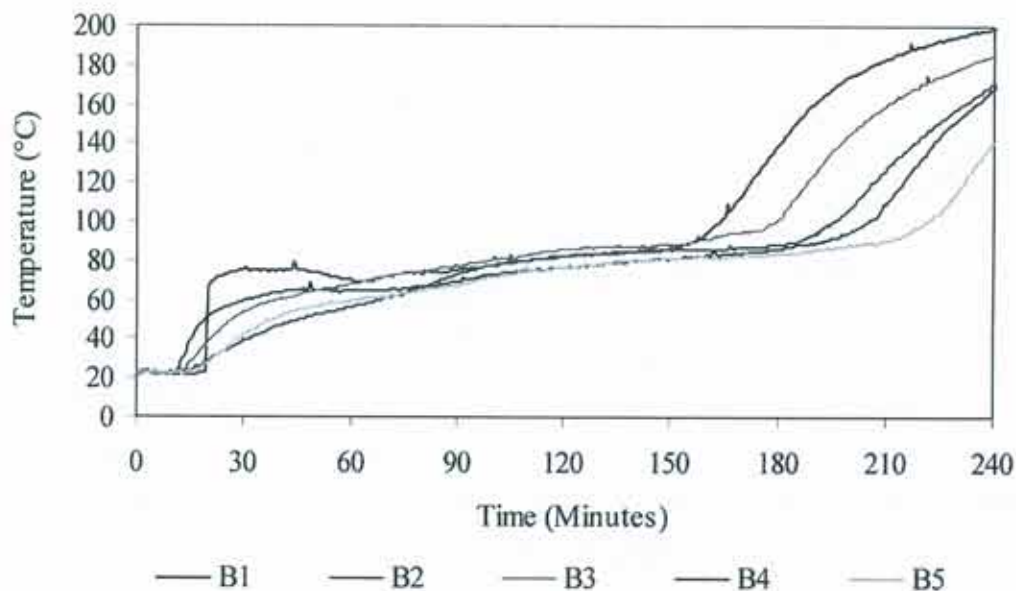
Figure A2.2: Temperatures on partition at 1/4 and mid point Vs Time

Element	T/C No.	DESCRIPTION	POSITON ¹	TEMP (°C) at t (minutes)						LIMIT ² (minutes)
				t=0	t=30	t=60	t=120	t=180	t=240	
Partition Surfaces (¼ & mid)	B1	TOP WEST ¼ POINT	x=750, y=2280	23	76	71	83	137	199	-
	B2	TOP EAST ¼ POINT	x=2250, y=2280	23	59	65	77	86	167	-
	B3	CENTRE PARTITION	x=1500, y=1520	23	54	68	85	99	185	-
	B4	BOTTOM WEST ¼ POINT	x=750, y=760	22	38	55	81	87	168	-
	B5	BOTTOM EAST ¼ POINT	x=2250, y=760	22	40	59	75	82	137	-
Partition Surfaces (Top Section)	B6	100mm FROM TOP EDGE	x=750, y=2940	23	43	62	79	92	165	-
	B7	100mm FROM TOP EDGE	x=1500, y=2940	23	64	68	74	81	101	-
	B8	100mm FROM TOP EDGE	x=2250, y=760	23	45	65	81	89	143	-
Partition Surfaces (Additional)	C5	ON STUD	x=2064, y=970	22	60	72	85	106	191	-
	C6	BETWEEN STUDS	x=1834, y=970	22	65	66	82	92	167	-
	C7	ON STUD	x=1378, y=970	22	57	71	88	102	188	-
	C8	BETWEEN STUDS	x=1154, y=970	23	68	66	85	92	169	-

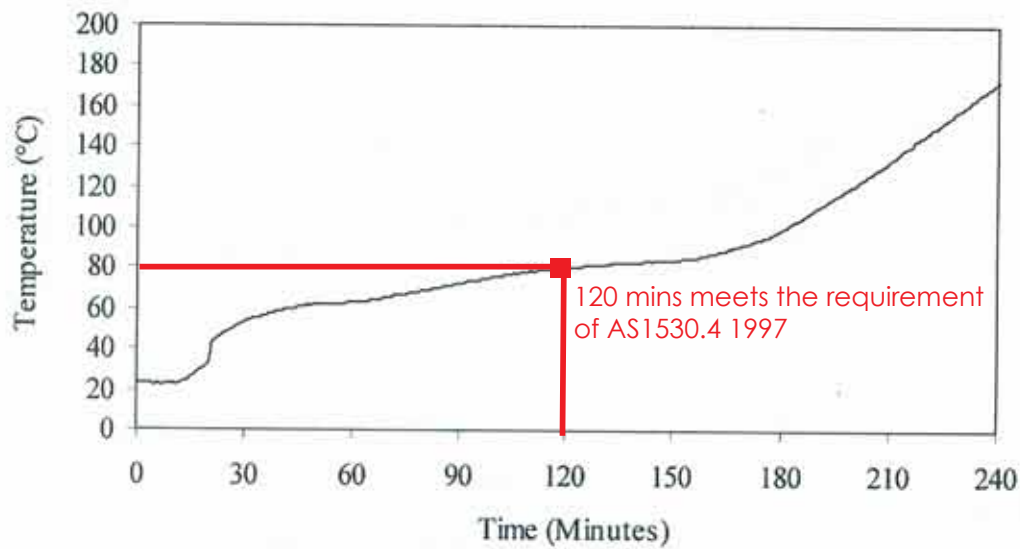
Figure A2.3: Average partition temperature (average of B1-B5) Vs Time

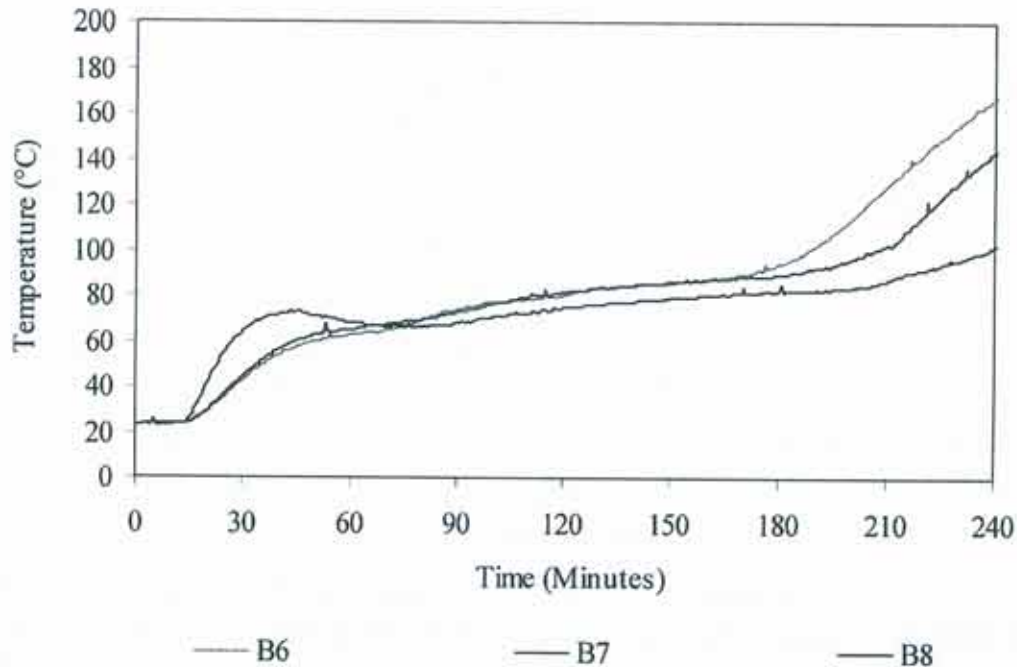
Figure A2.4: Temperatures at top section of partition Vs Time

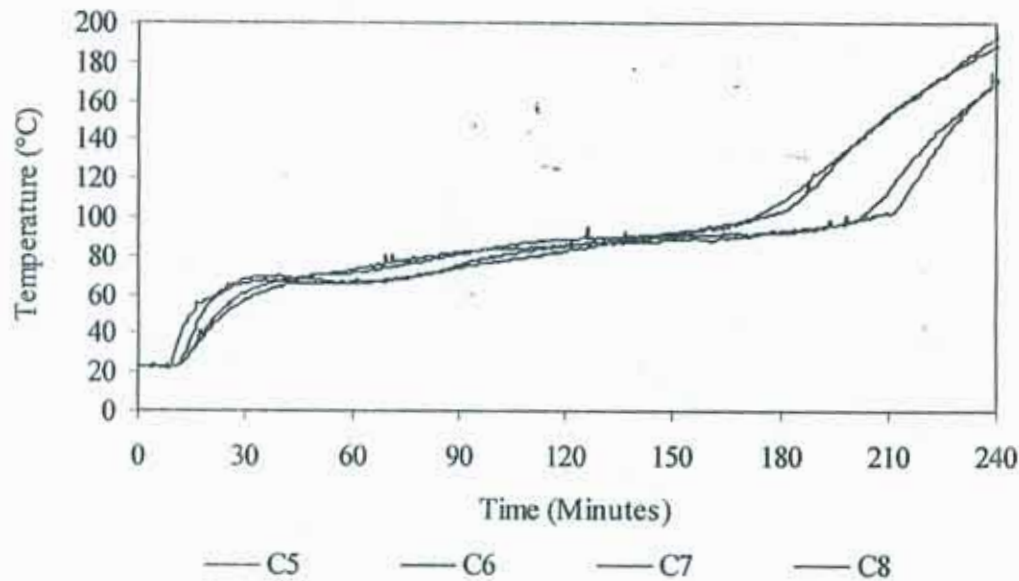
Figure A2.5: Temperatures at lower-mid section of partition Vs Time

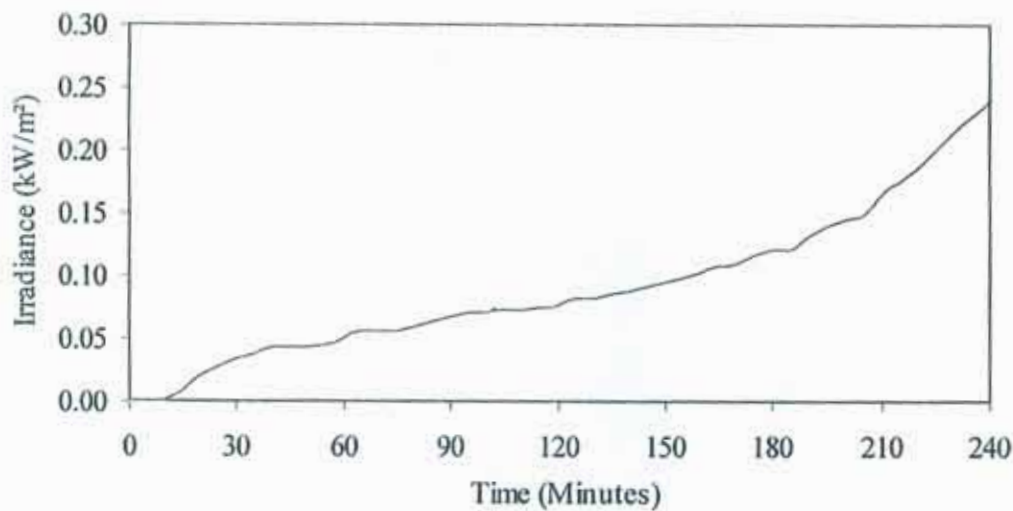
Figure A2.6: Radiation emitted from partition Vs Time

The Radiometer was positioned 2255mm above floor level (coinciding with centre point of partition) with a viewing angle of 60°, and was placed 3702mm away from the specimen.

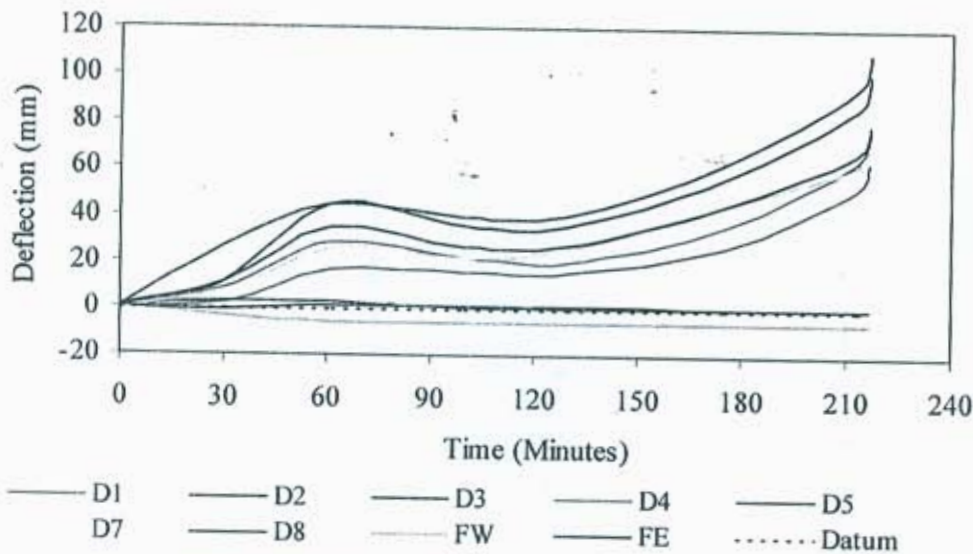
Figure A2.7: Out-of-Plane Deflection of Wall Vs Time

*Positive measurements was movement of partition inward (towards furnace) and
Negative measurements was movement of partition outward (away from furnace)*

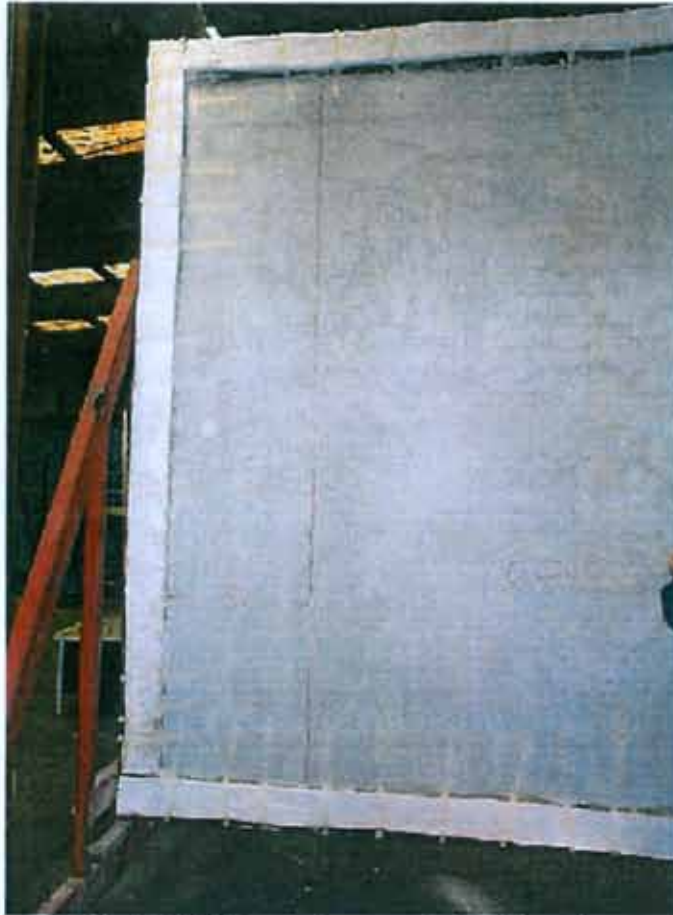
Plate 1: Exposed face vertical hairline crack on eastern side prior to commencement of the fire resistance test.

A2.2.1 Two material cracks of hairline thickness were noted in the exposed face of the test specimen. One crack ran vertically down the specimen and was approximately 610mm from the eastern edge. The position of this crack appeared to coincide with the position of the join in the steel weld mesh that was under the layers of insul-crete sunblok. The second crack was a horizontal crack and was approximately 810mm long and started from the western edge of the test specimen 1100mm from the bottom. These cracks had occurred during the curing cycle (Refer Plates 1 and 2 in Appendix 3 for further information).

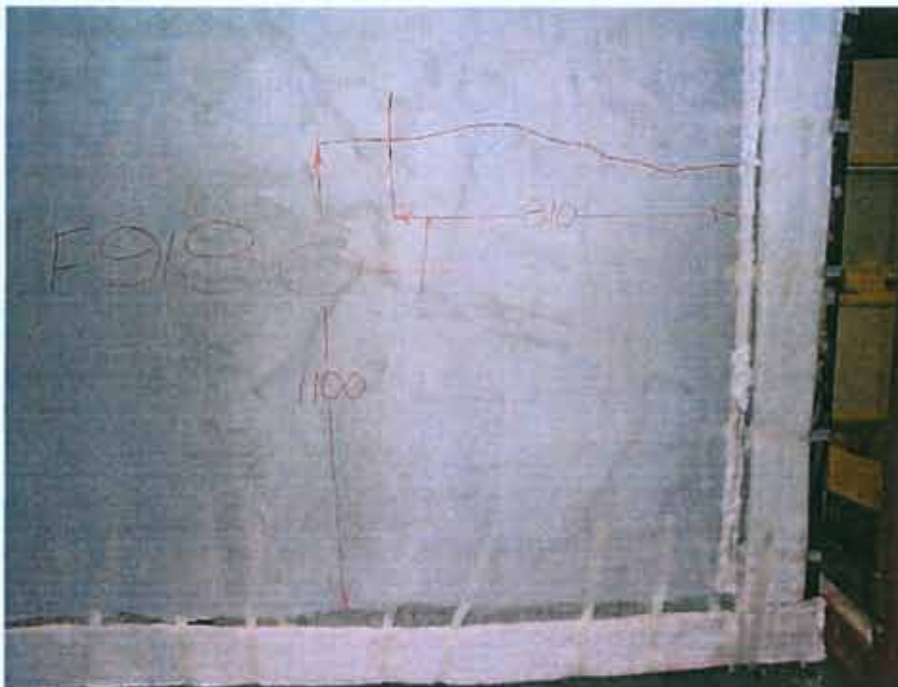
Plate 2: Exposed face horizontal hairline crack on western lower corner prior to commencement of the fire resistance test.

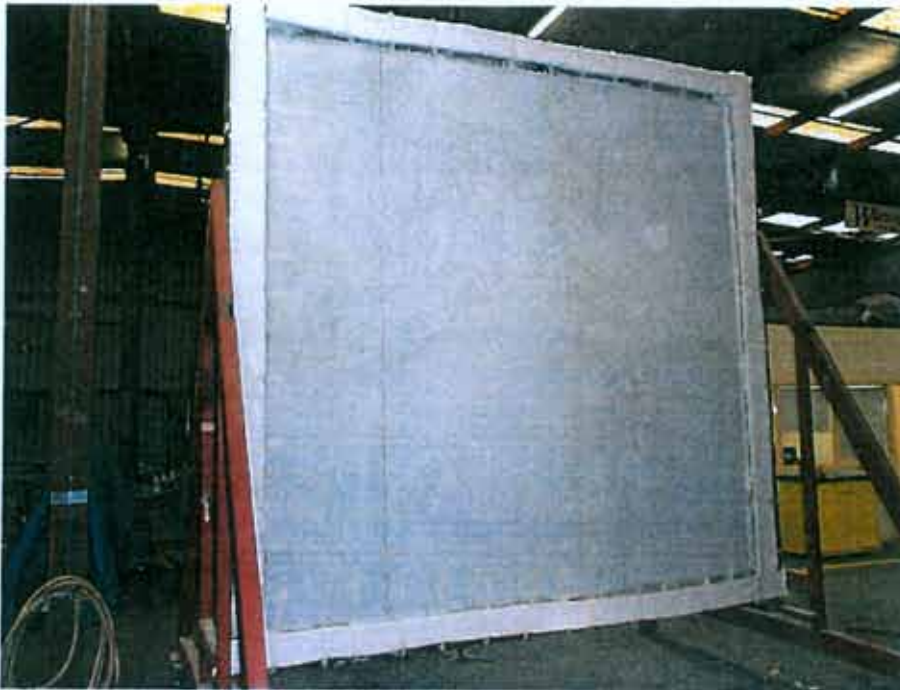
Plate 3: Exposed face Prior to Commencement of the fire resistance test.

- PLATE 1: Exposed face vertical hairline crack on eastern side prior to commencement of the fire resistance test.
- PLATE 2: Exposed face horizontal hairline crack on western lower corner prior to commencement of the fire resistance test.
- PLATE 3: Exposed face prior to commencement of the fire resistance test.
- PLATE 4: Unexposed face prior to commencement of the fire resistance test.
- PLATE 5: Unexposed face after approximately 120 Minutes Test Duration.
- PLATE 6: Unexposed face after completion of the fire resistance test.
- PLATE 7: Exposed face after completion of the fire resistance test and after being detached from the furnace.

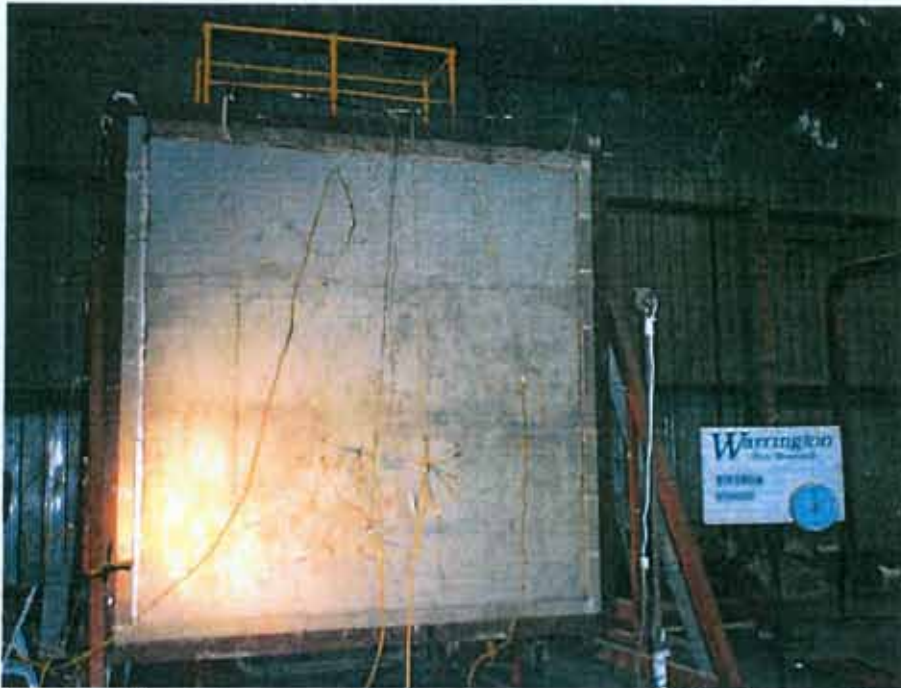
Plate 5: Unexposed face of test specimen after approximately 120 Minutes Test Duration.

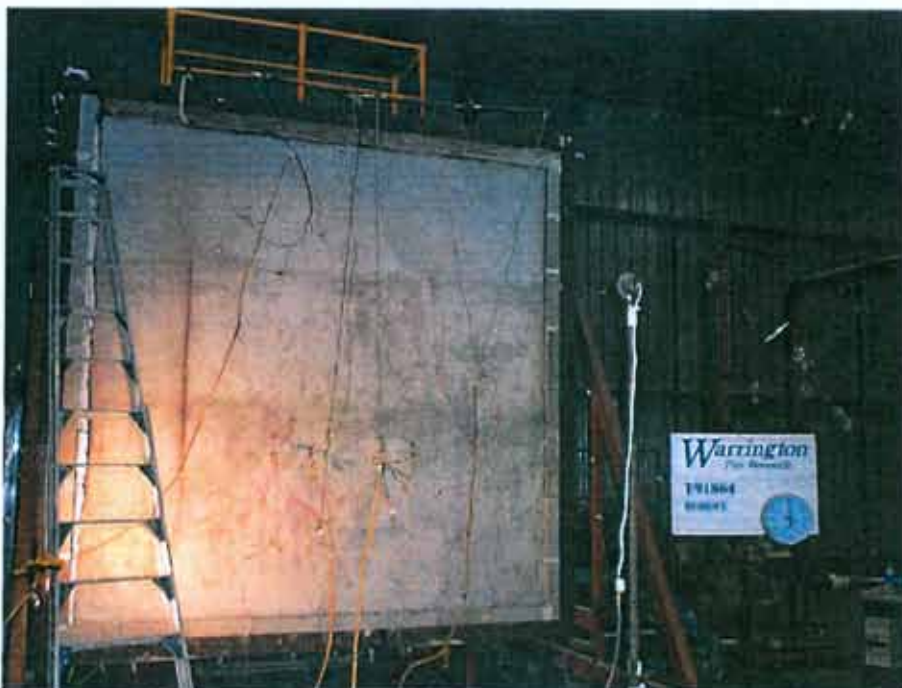
Plate 6: Unexposed face of test specimen after completion of the fire resistance Test.

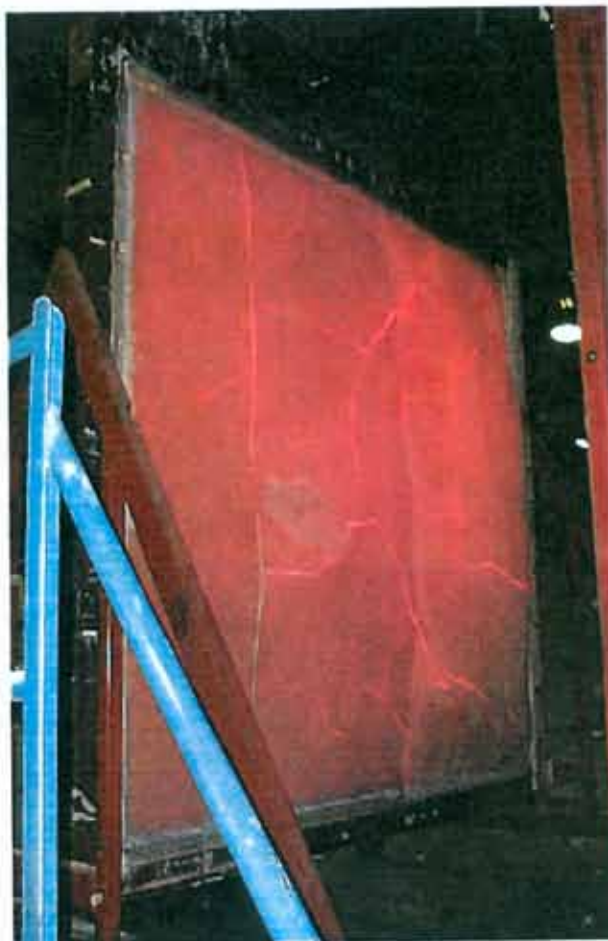
Plate 7: Exposed face of test specimen after completion of the fire resistance test and after being detached from the furnace.
